Report on the geomorphic condition, and protection and rehabilitation priorities for Mulwaree chain-of-ponds

PROFESSOR KIRSTIE FRYIRS

As part of an Australian River Restoration Centre (ARRC) project.

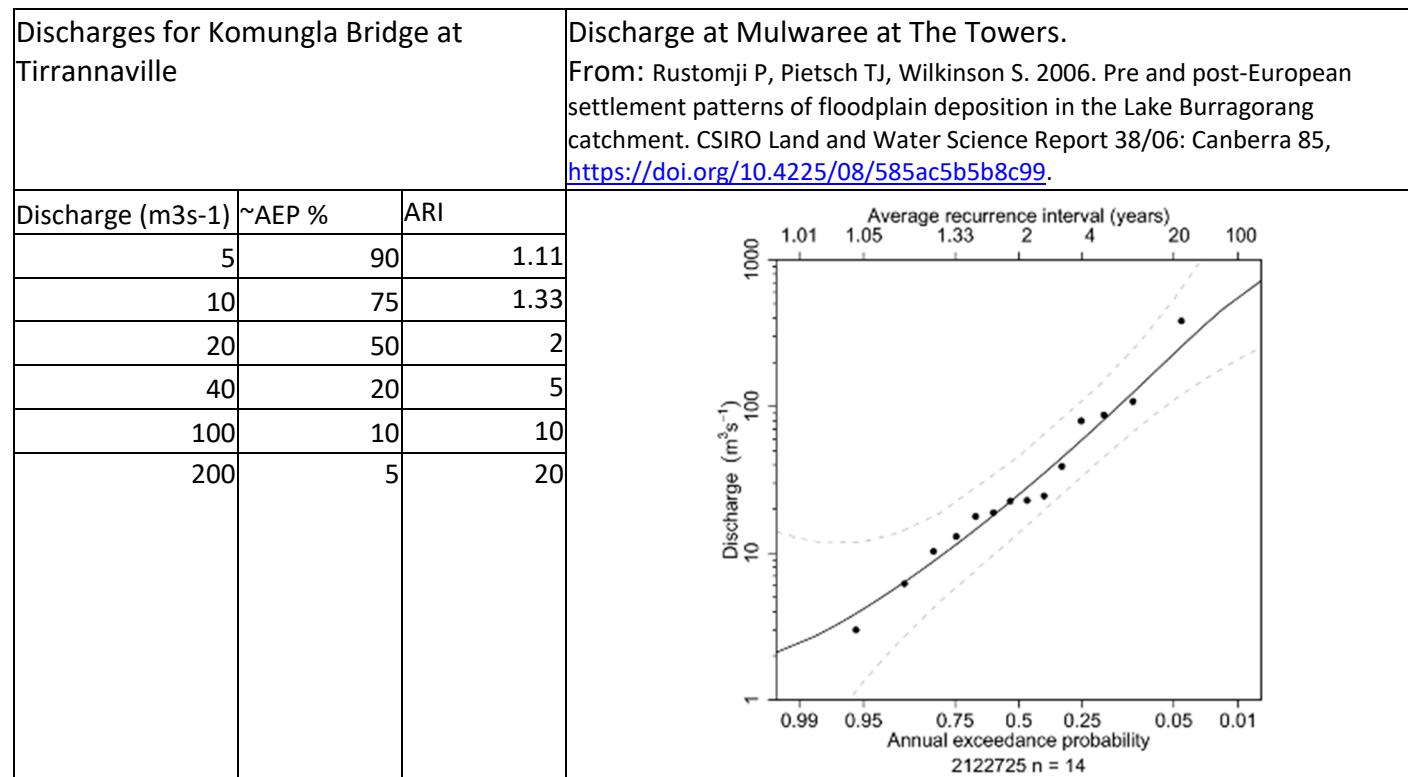
- Hec-Ras was run on the 5m Digital Elevation Model (DEM) for the full length of Mulwaree from near Lake Bathurst to Goulburn.
- Six discharges were modelled. Only the 1:20 yr AI is provided as it gives the best analysis for identification of erosion hotspots (see Appendix A and B).

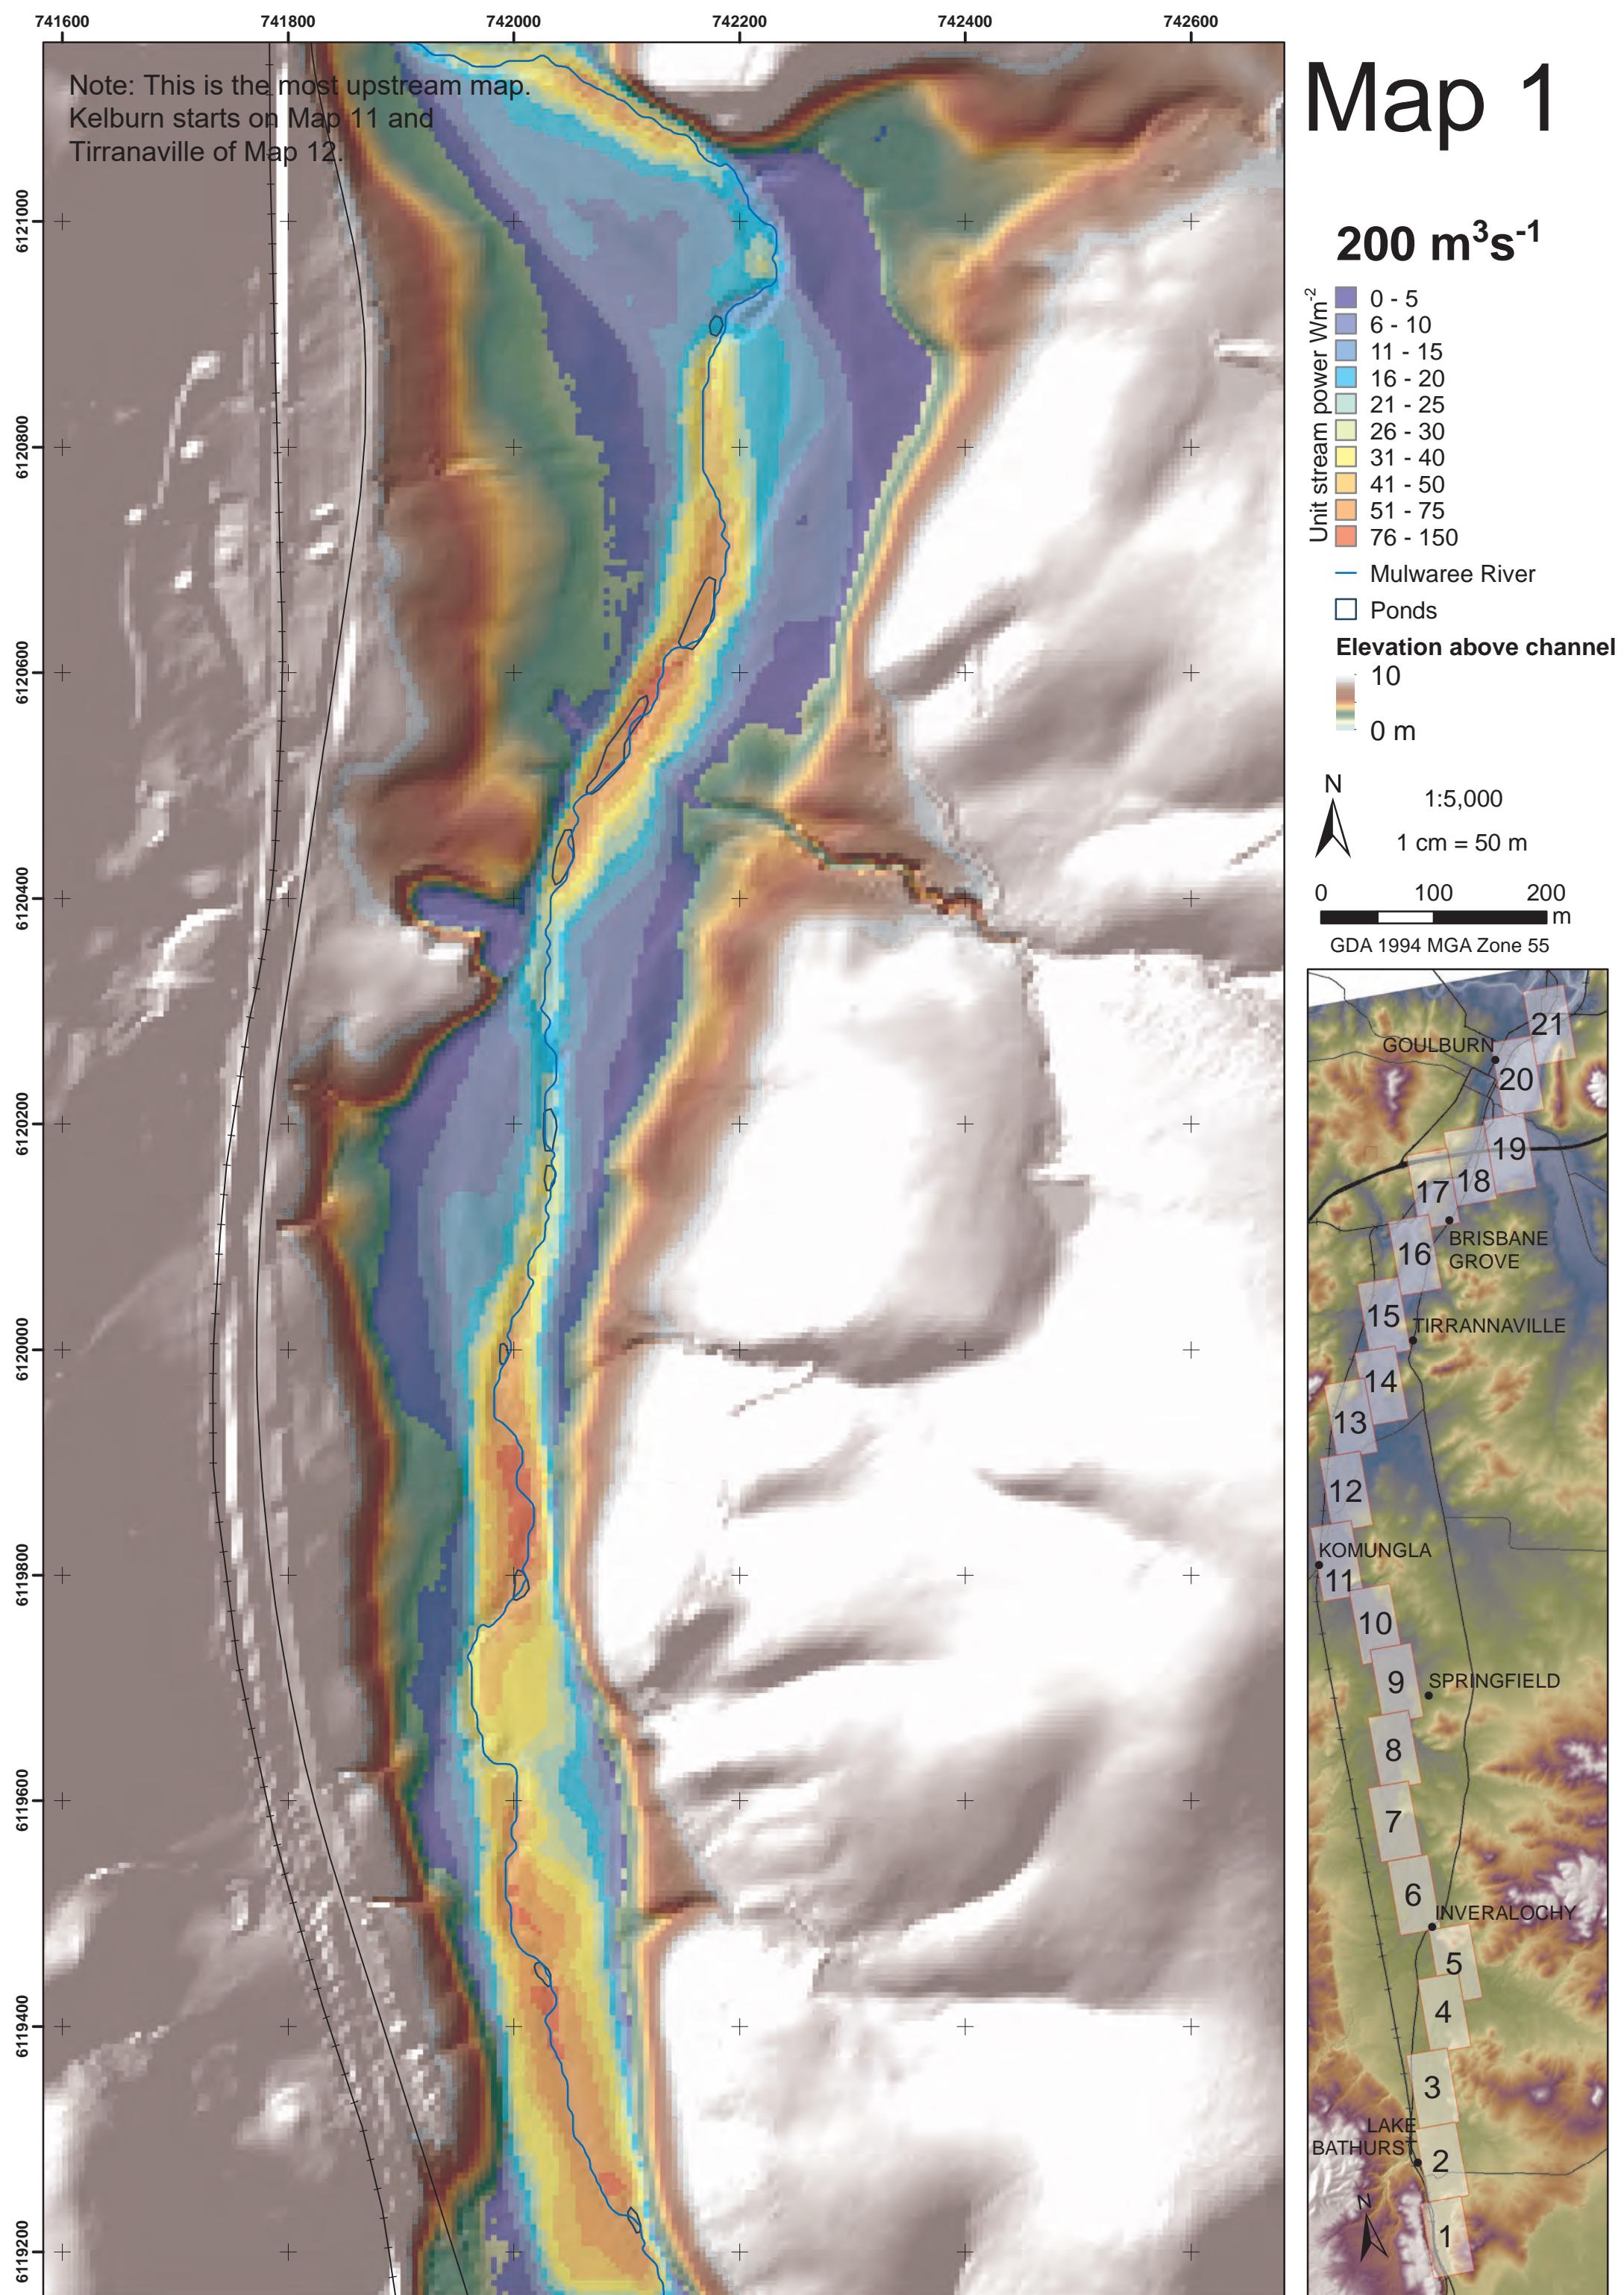
Map 1

What do the colours mean? – In Appendix A anything that is yellow, orange or red is considered an erosion hotspot ($>30 \text{ Wm}^2$).

What is the interpretation of this modelling? – The erosion hotspots along Mulwaree are mostly occurring at the exit of ponds where flow is being forced into an adjoining connecting (incised) channel downstream. This process is occurring most actively at ‘bankfull’ stage when pond level rises above its ‘exit lip’ and flow is filling the connecting channels. You will see that the areas downstream of ponds that are blue or purple are low energy zones. These are areas where preferential flow paths remain intact and flow is dissipated over swampy ground and adjacent floodplains when it exits a pond. The aim of rehabilitation (or conservation) is to retain the blue and treat the orange and red areas to recover them towards blue. Erosion processes start to occur during the 1:10 yr flood ($100 \text{ m}^3\text{s}^{-1}$) and most actively during the 1:20 yr flood ($200 \text{ m}^3\text{s}^{-1}$) (Appendix A output). Some minor erosion hotspots occur during the 1:5 yr flood ($40 \text{ m}^3\text{s}^{-1}$).

Appendix A Hec-Ras unit stream power modelling for the 1:20 yr flood ($200 \text{ m}^3\text{s}^{-1}$) on the elevation layer.

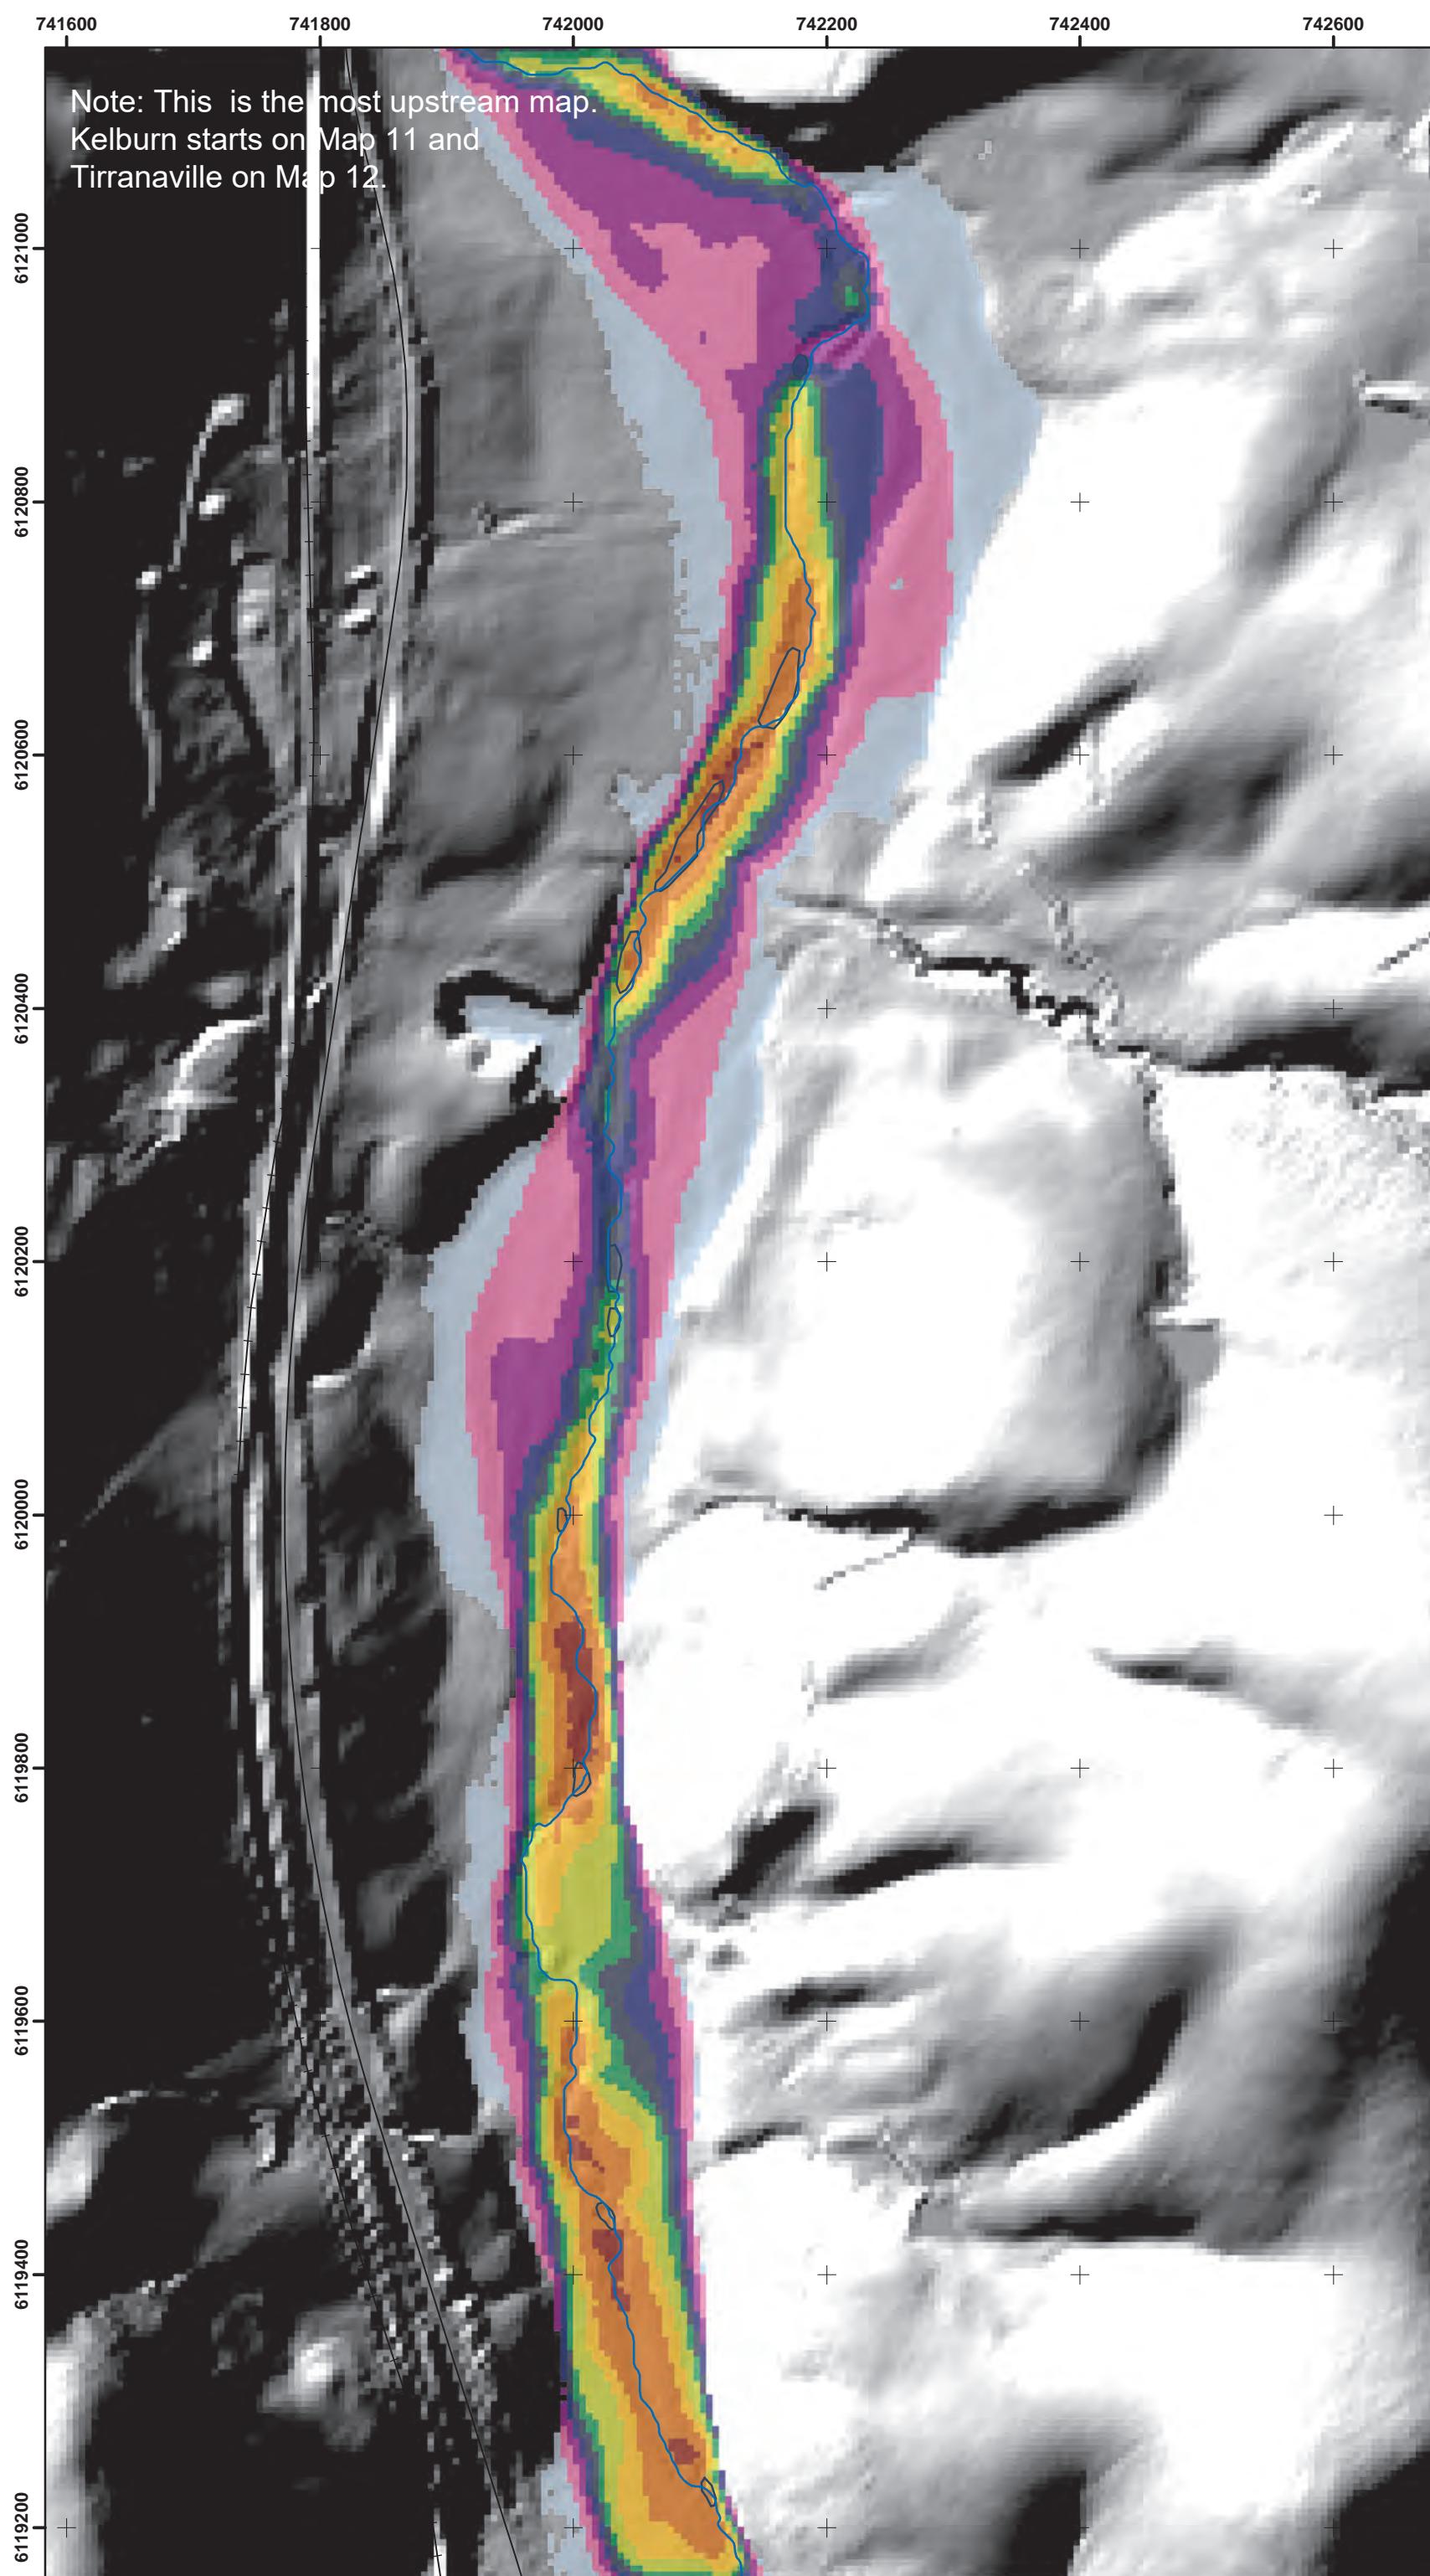
Map 1

Appendix B Hec-Ras unit stream power modelling for the 1:20 yr flood ($200 \text{ m}^3\text{s}^{-1}$) on the hillshade layer.

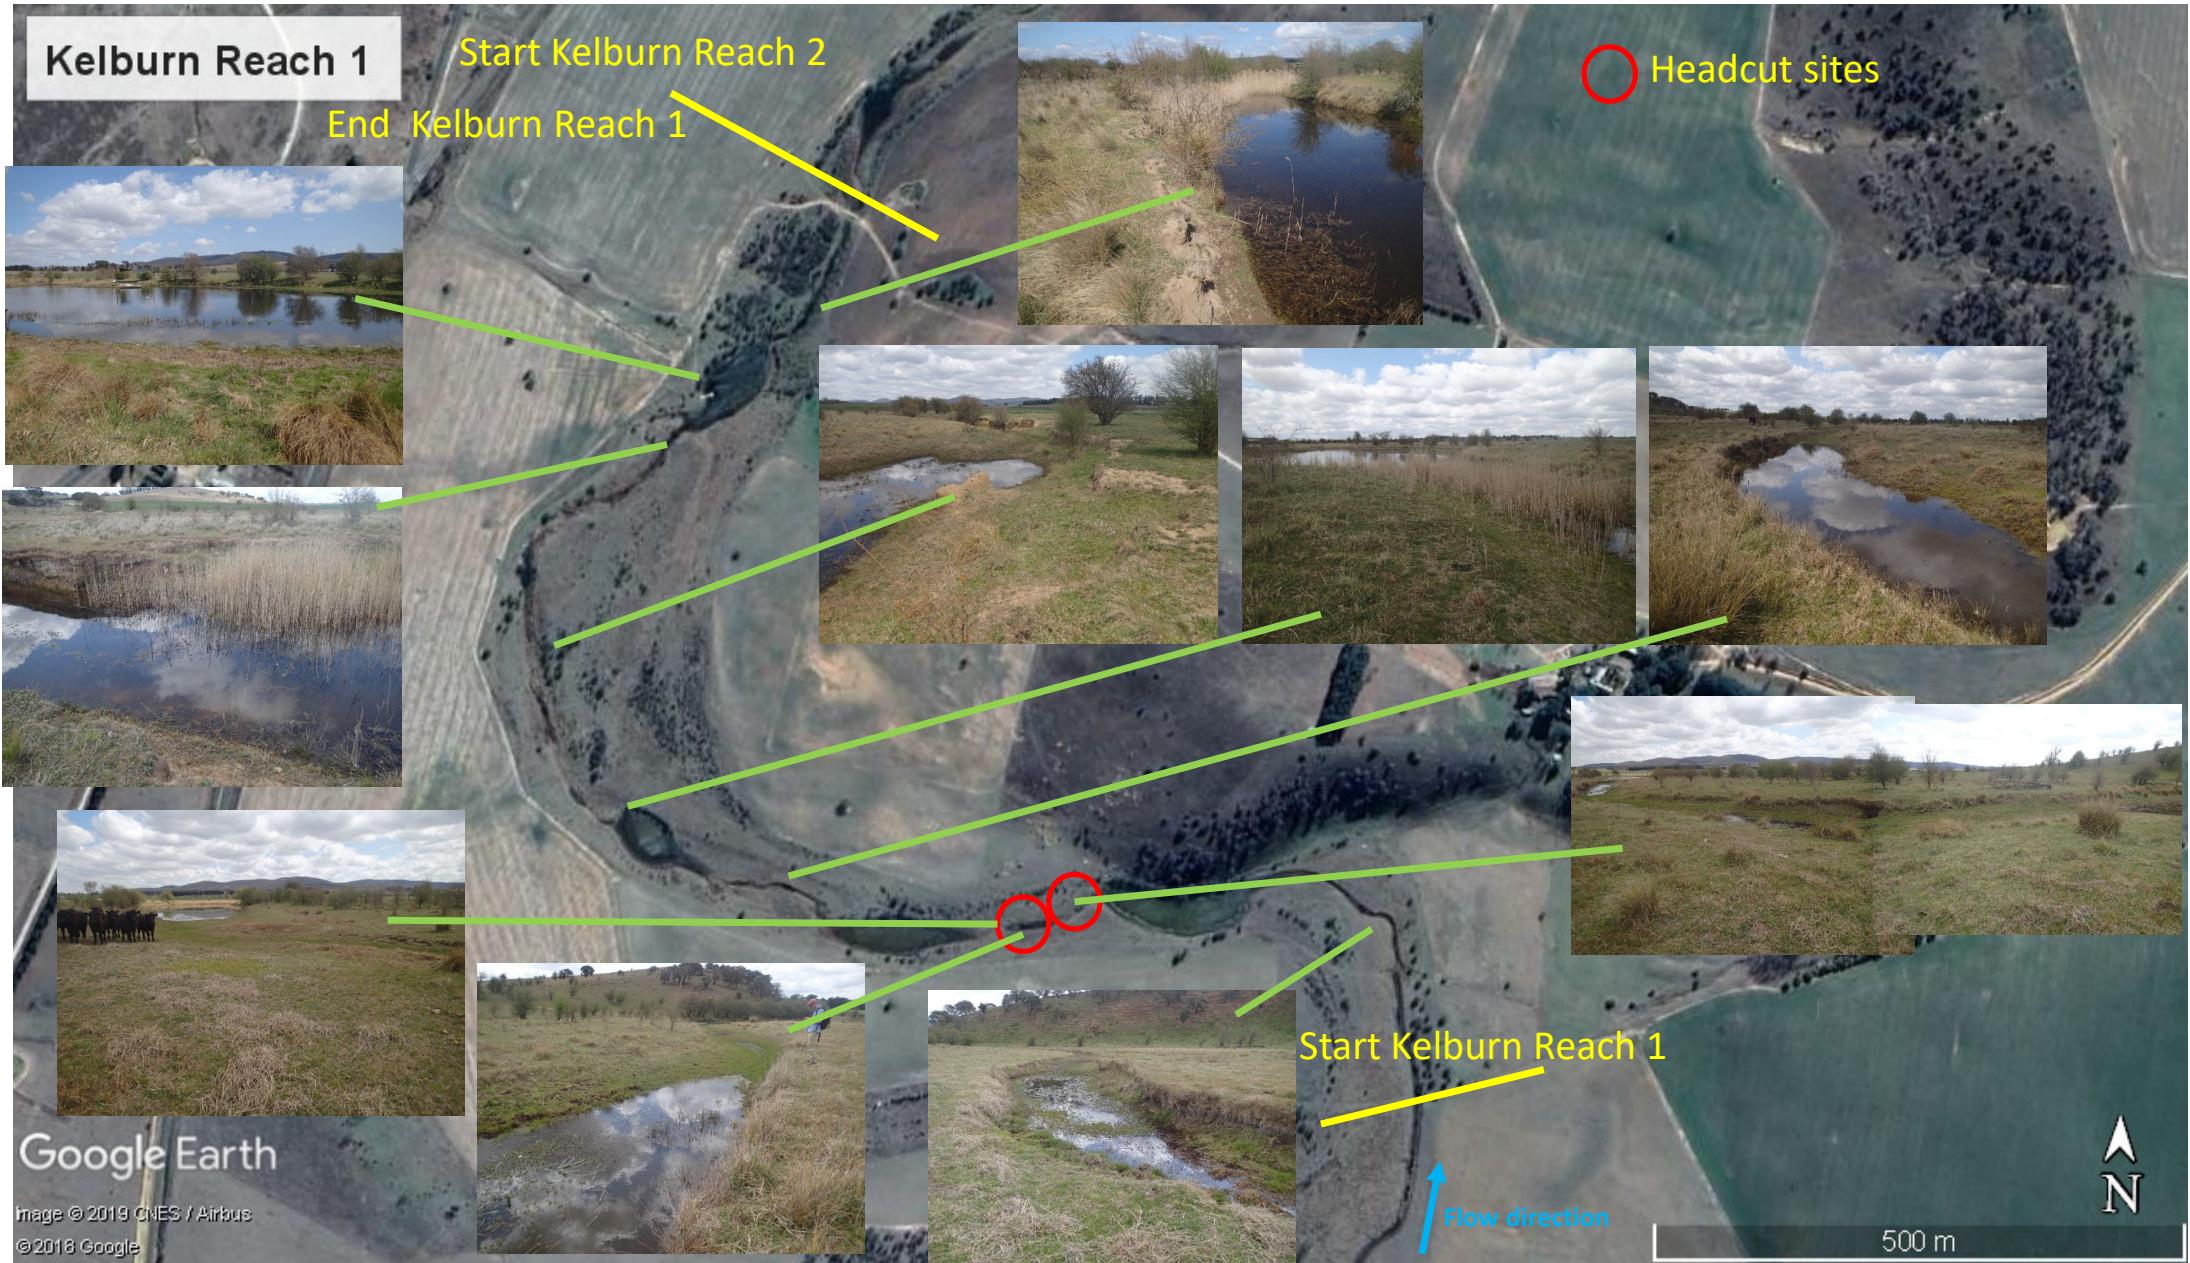
Reach/Condition	Kelburn Reach 1	Kelburn Reach 2	Tirranaville Reach 1	Tirranaville Reach 2	Tirranaville Reach 3	Tirranaville Reach 4
Description	poor condition chain of ponds with incised channels (contains headcuts as threats)	intact chain of ponds with preferential flow paths (contains headcuts as threats)	incised channel with no ponds remaining	poor condition chain of ponds with incised channel that is now recovering	intact chain of ponds with preferential flow paths (contains headcuts as threats) – already an identified RoC potential site/reach	elongate ponds with rehabilitation
Condition (green = Good, red = Poor)

Priority 4 – Kelburn connecting channels. There are several connecting channels between ponds at Kelburn in Reach 1 that are severely eroded. Existing fencing is in place along most of these reaches. Some reed beds are re-establishing at the erosion hotspots at the exit zones to some ponds. The reed beds should be enhanced and extended downstream, particularly at the headcuts in Kelburn Reach 1. Getting aquatic roughness back into the connecting channels at these hotspots and in the reaches immediately downstream will likely prevent further incision and channel erosion in the pond exit zones. More appropriate stock management is required for all these reaches to allow reinforcing grasses and aquatic vegetation to come back naturally or directly along the incised channels.

Headcut sites

Priority 1 – off-river stock water points and stock management. We recommend this particularly at Kelburn. Stock are an ongoing threat to the integrity of the ponds and are causing further erosion of connecting channels. Exclusion is recommended at headcuts and along ‘intact’ reaches (see Priority 2 & 3).

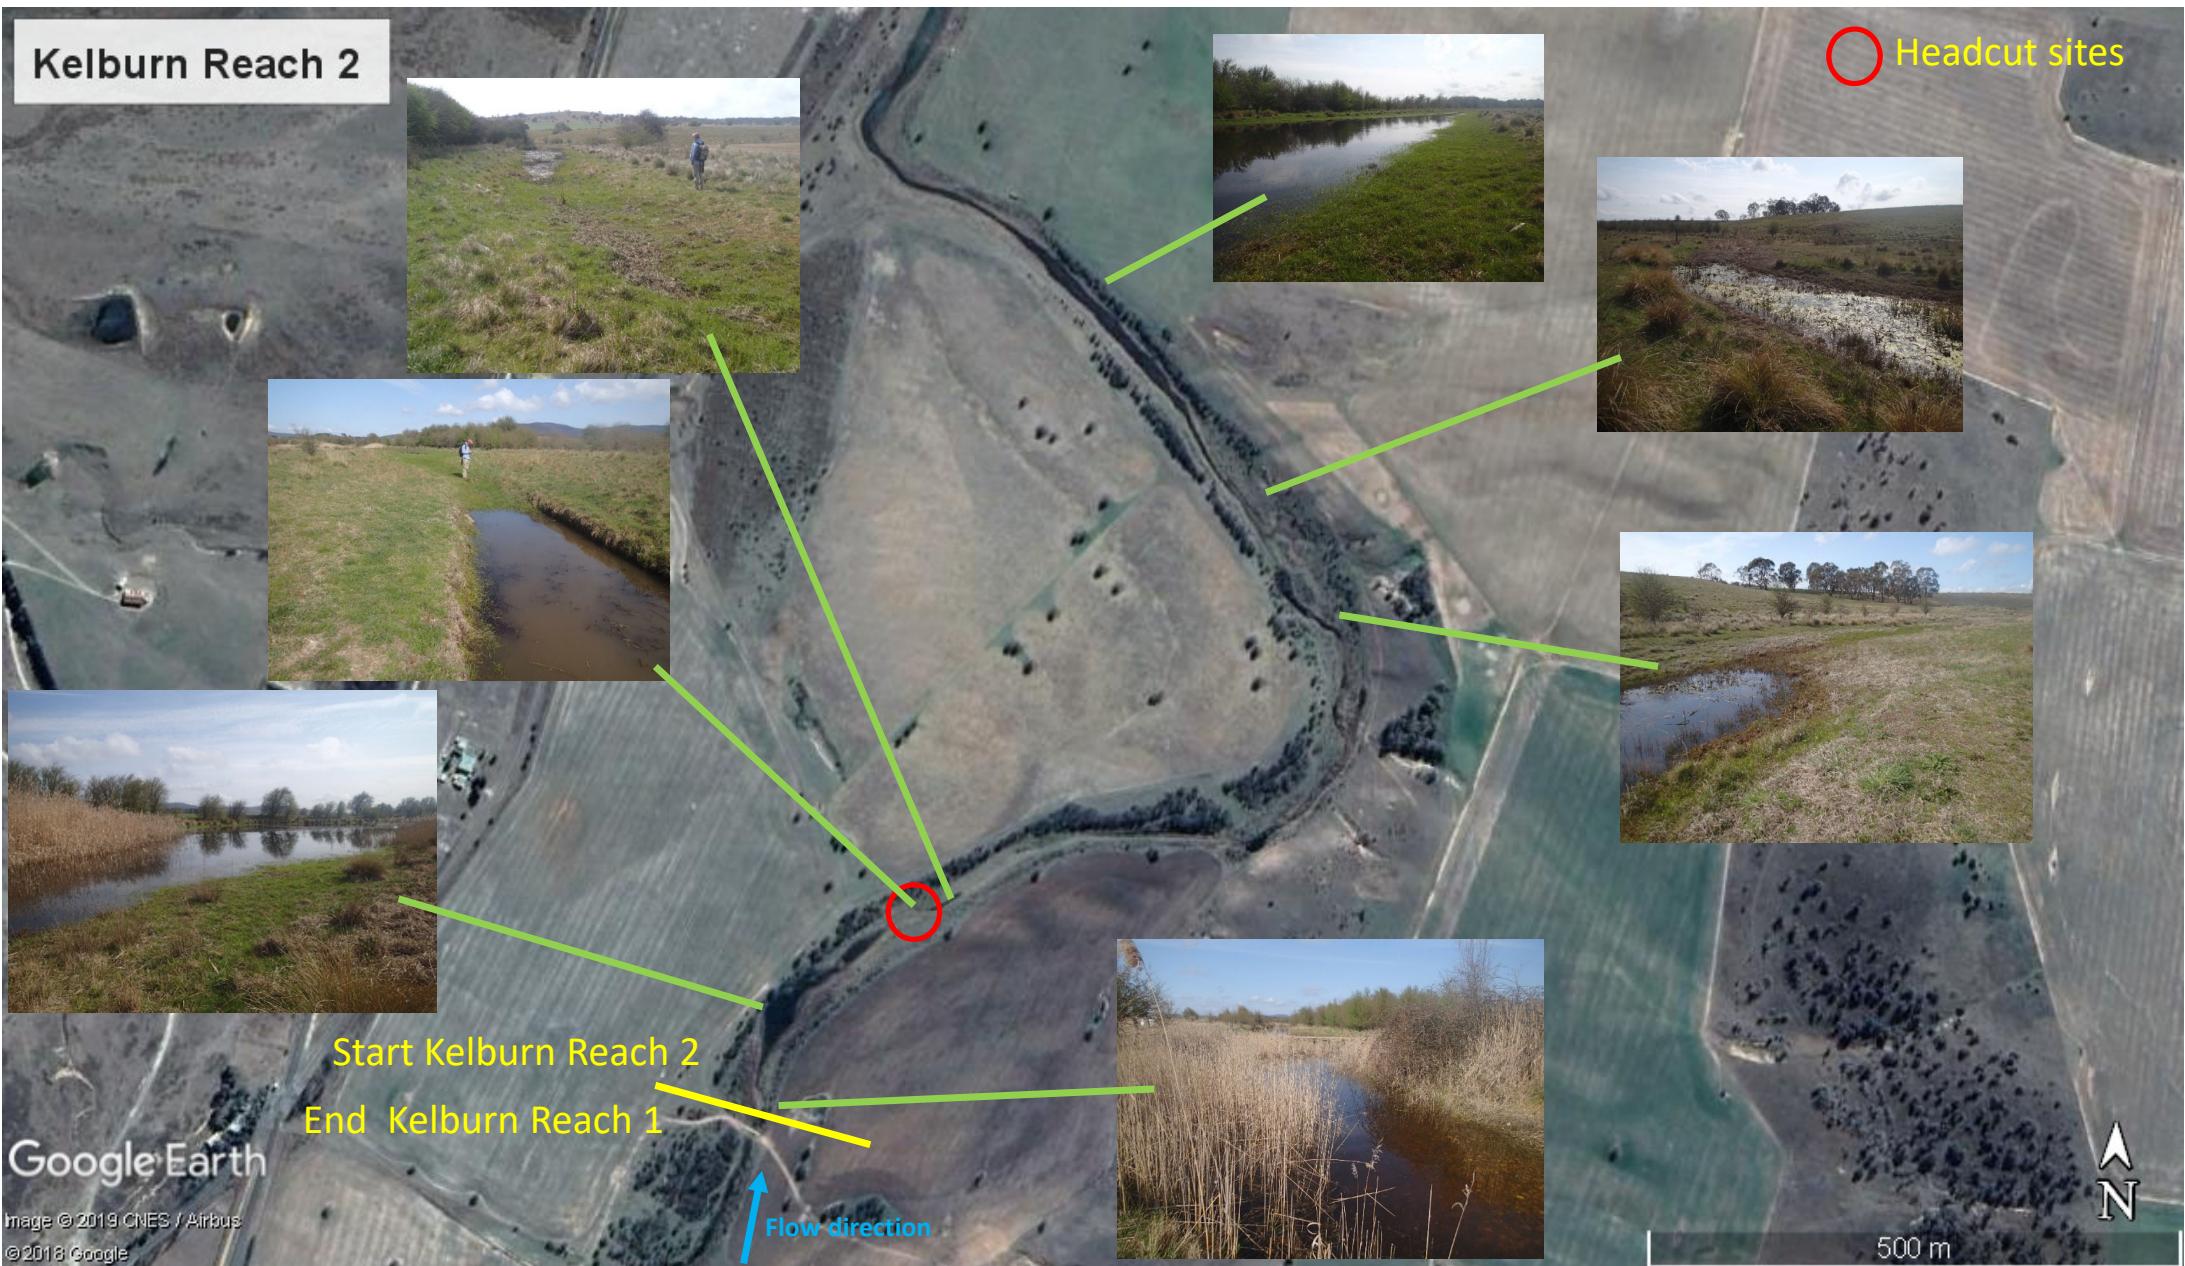
Kelburn Reach 2

Priority 2 - Look after the identified ‘intact’ reaches at Tirranaville (Reach 3) and Kelburn (Reach 2). The Tirranaville reach has already been identified by RoC as a possible site for work. Extend fencing from existing downstream sites, upstream into this reach. Allow aquatic vegetation to re-establish. Added benefit of working in this reach is that it extends upstream from existing works and previous projects at Tirranaville. At Kelburn there is existing fencing on the west-bank but not on the east bank. Connecting part of the unfenced chain-of-ponds corridor is recommended. Limit or exclude stock access to these reaches.

Priority 3 – Monitor and manage identified headcuts. We identified five headcuts in the system (2 at Tirrannavlle and 3 at Kelbun) in Priority 2 and 4 reaches. Although they have not moved for some time, and all are relatively gradual headcuts, all are exposed to disturbance and could pose a threat to the integrity of ponds in the reaches in which they occur. This is particularly the case in Priority 2 reaches, which we recommend be considered first in parallel with the Priority 2 strategy. We recommend that the headcuts be monitored over time, the reaches fenced off, stock excluded and aquatic revegetation (natural or direct) be undertaken particularly around the headcuts to ensure sufficient roughness to withstand flood flows. At this stage we do not recommend any direct works or heavy interventions at these headcuts that would exacerbate them and make them unstable.

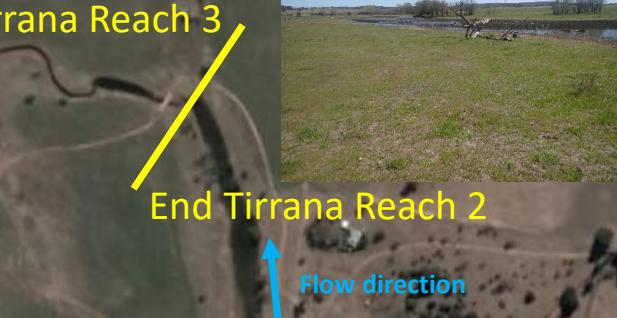
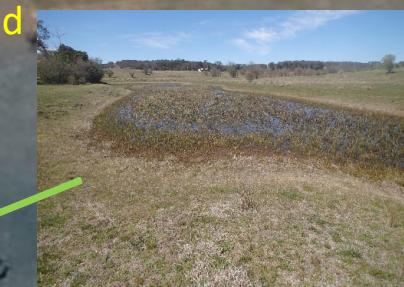
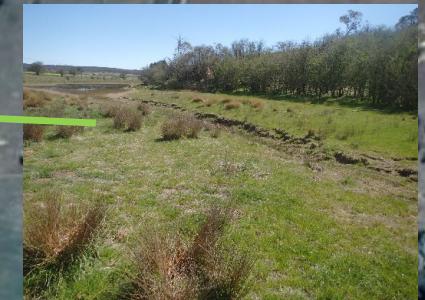
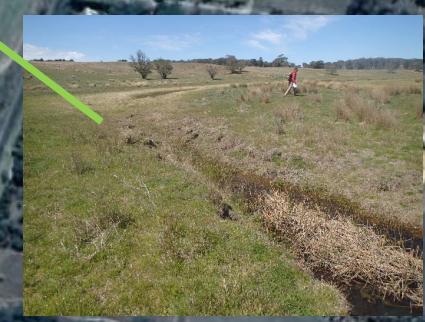
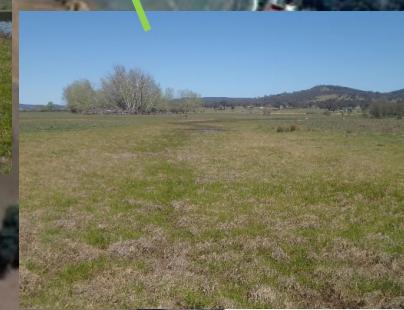
Headcut sites
